Diebold Vault Door: 1 of 4**Kolekcja:** American 19th-20th Century Safes**Muzeum:** Historic Padlocks and Safes**Właściciel:** oshkoshlock

Opis: Diebold Safe & Lock Company (Canton, Ohio-USA) - Circa 1920. This is all the workings from a vault door - removed from the 3" thick steel slab. It has been re-mounted on heavy boards in the precise original configuration.

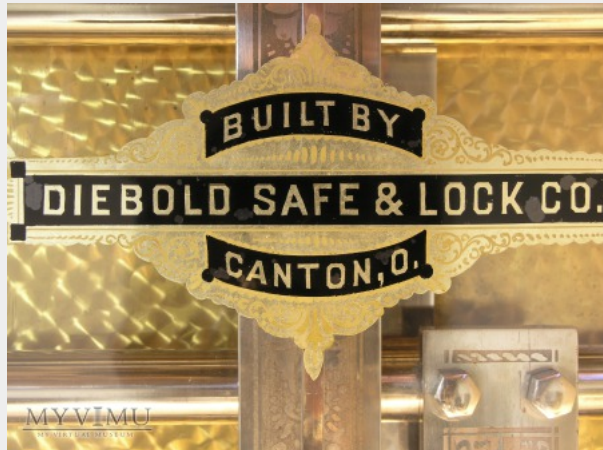
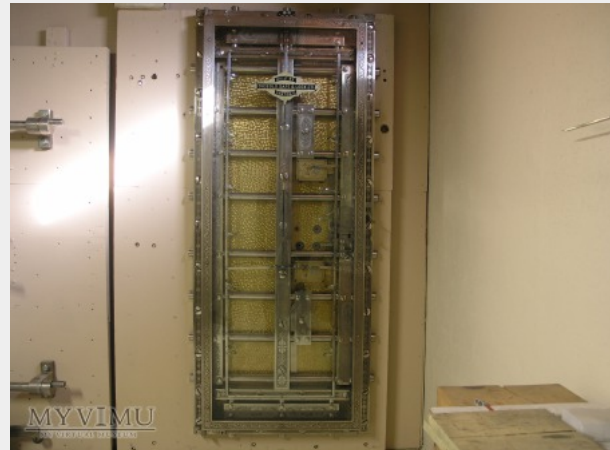
- "1." The door insigne
- "2." Full view with door closed
- "3." Full view with door open
- "4." Various sections going from top to bottom

When complete, this door weighs approx. 3,000 lb. (1361 kg.) and has 16 horizontal (8 left, 8 right) and 6 vertical locking bolts (3 top, 3 bottom). It has two independent three wheel combination locks connected by a vertical bar which allows for dual custody (you can move the locking bolts and open the door by working just one of the combination locks).

Between the two combination locks is a timelock (removed and shown separately). Unless the timelock has wound down to "zero hours" on at least 1 of the 3 clocks (chronometers) the bolts cannot be retracted (door opened).
