Diebold Vault Door: 3 of 4**Kolekcja:** American 19th-20th Century Safes**Muzeum:** Historic Padlocks and Safes**Właściciel:** oshkoshlock

Opis: Diebold Safe & Lock Company (Canton, Ohio-USA) - Circa 1920. This is all the workings from a vault door - removed from the 3" thick steel slab. It has been re-mounted on heavy boards in the precise original configuration.

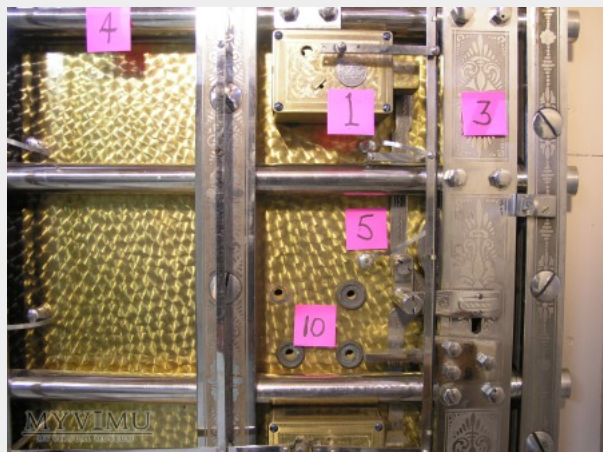
"a."----- The three movement timelock. Notice the rectangular slot on the lower right hand side. This slot accepts the bar -- allowing the bolts to be retracted - and the door to open.

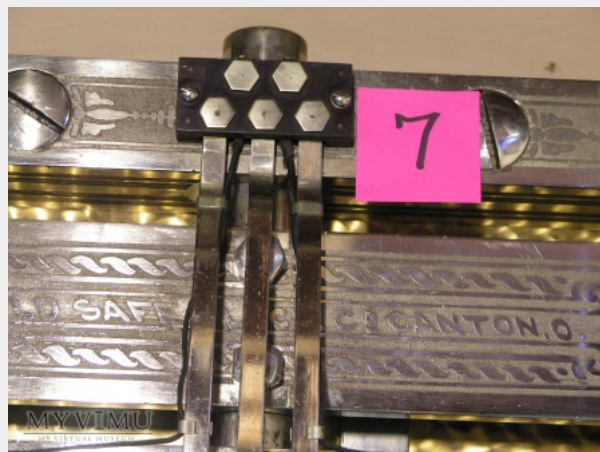
"b." ---- Picture "7" shows the point at which the alarm wire - which surrounds the door -- makes connection with a similar contact on the door frame.
